# Dry Weather Screening to IDDE : A Gas Well Incident - Case study

City of Denton

Watershed Protection

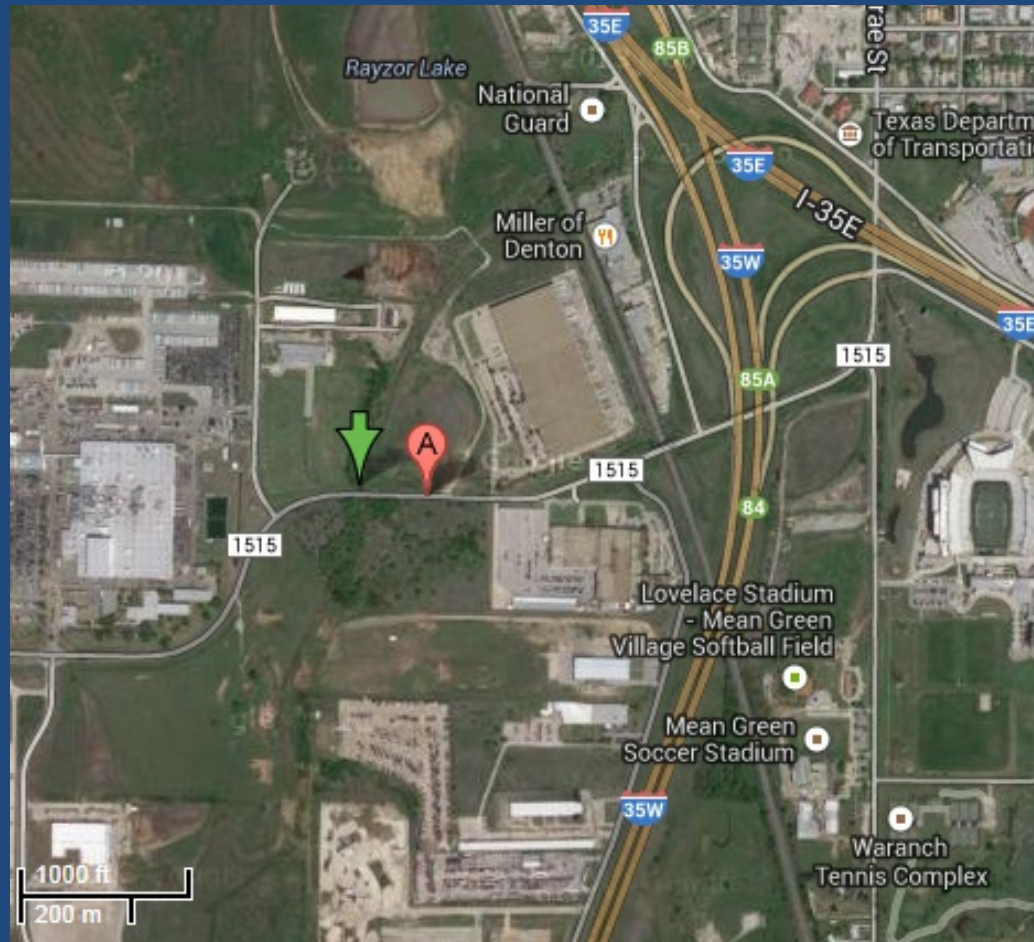
- Site 2: Airport Rd
  - Hickory Creek Tributary
  - Adjacent to Gas Well Pad Site
  - Small drainage area west of I-35
  - 4 businesses upstream, none of which have a stormwater permit
    - NECs

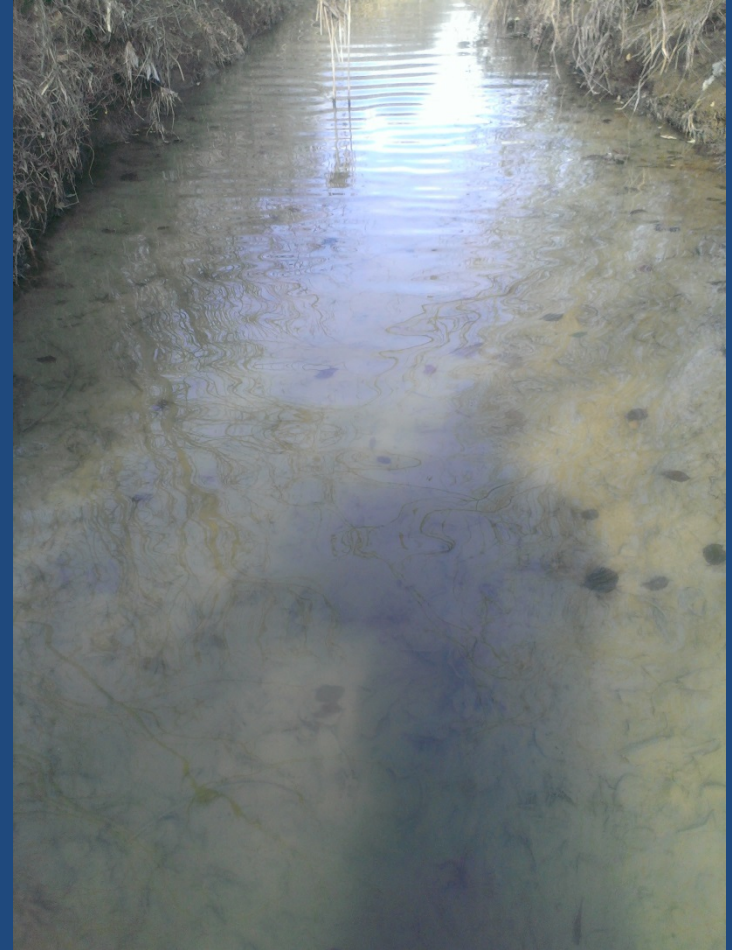
- Odd odor, reminiscent of hydrocarbons but not discernible (to me)
- Unusual sheen with black, fibrous splotches
- Conductivity reading of **26,000 us/cm**

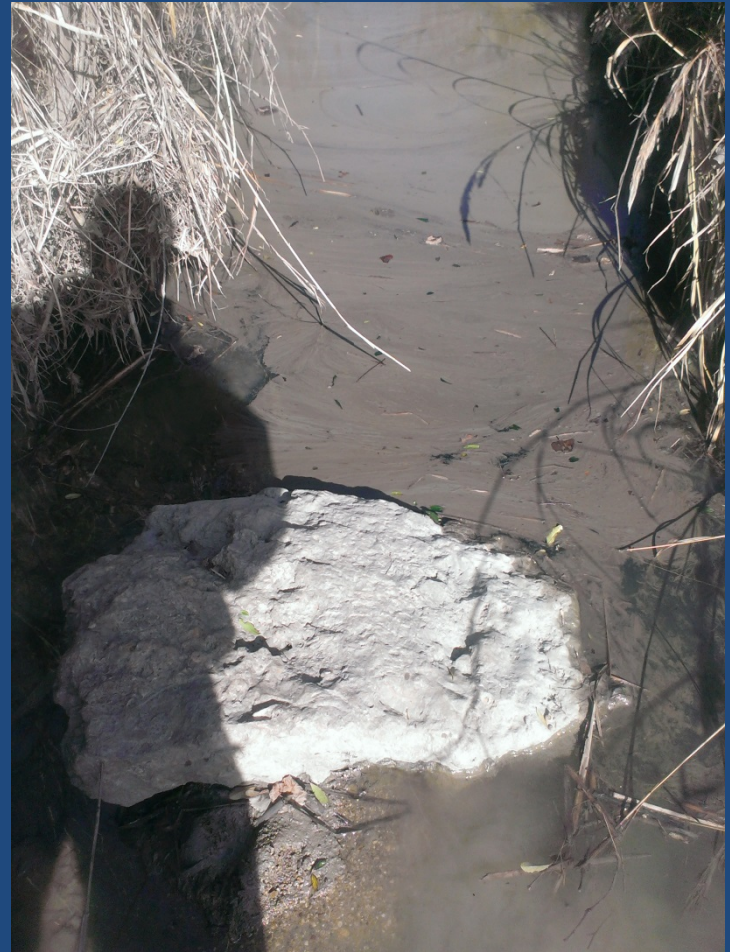
- A small debris dam (rock and vegetation) holding back potential unknown IDDE material
- Grey and brown sludge backed up ~50 meters

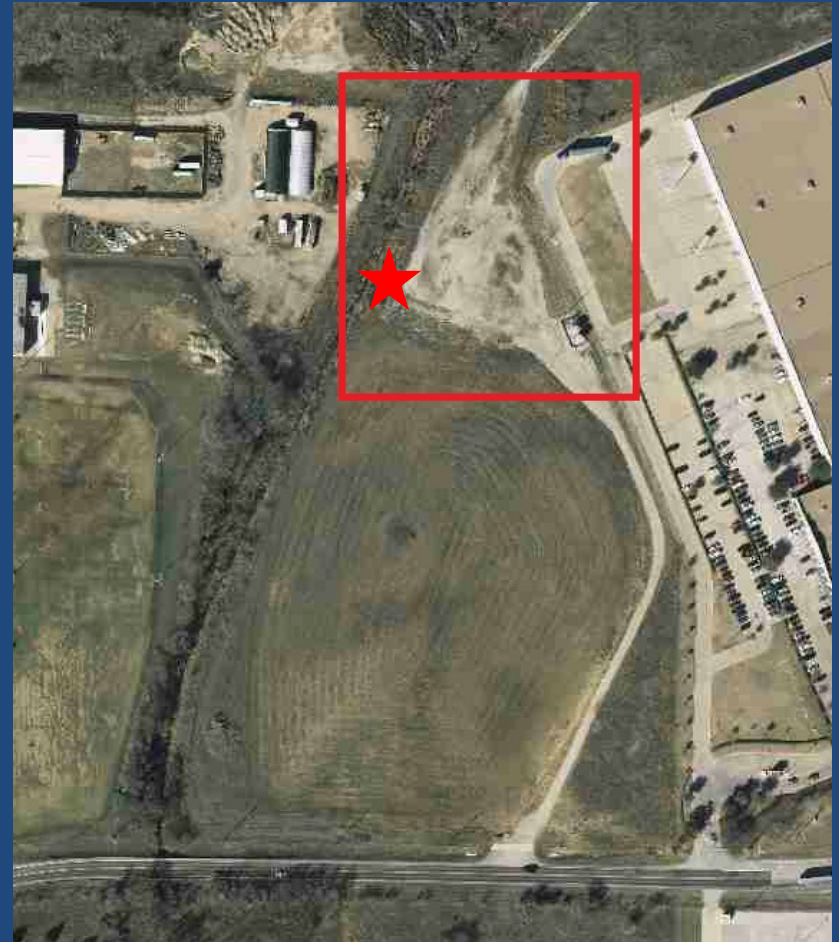
- Gas Well Pad Site
  - Was actively being fracked at the time of incident
  - 2013 and 2015 aerials do not show the operation but **square** is pad-site
- Drilling Fluid was being stored on-site (**star**) mere yards from stream
  - Obvious discharge path under degraded BMPs (no pic, oops!)

- (1) Immediately remove all free-standing produced fluids from the ground surface.*
- (2) Repair or replace all leaking equipment and BMPs.*
- (3) Conduct excavation operations to vertically and horizontally delineate all areas affected by produced fluids.*
- (4) Initiate and complete remedial clean-up operations for all areas affected by produced fluids to promote aeration and natural remediation.*
- (5) Provide the District Office with a remedial plan and documentation that all cleanup operations are complete.*

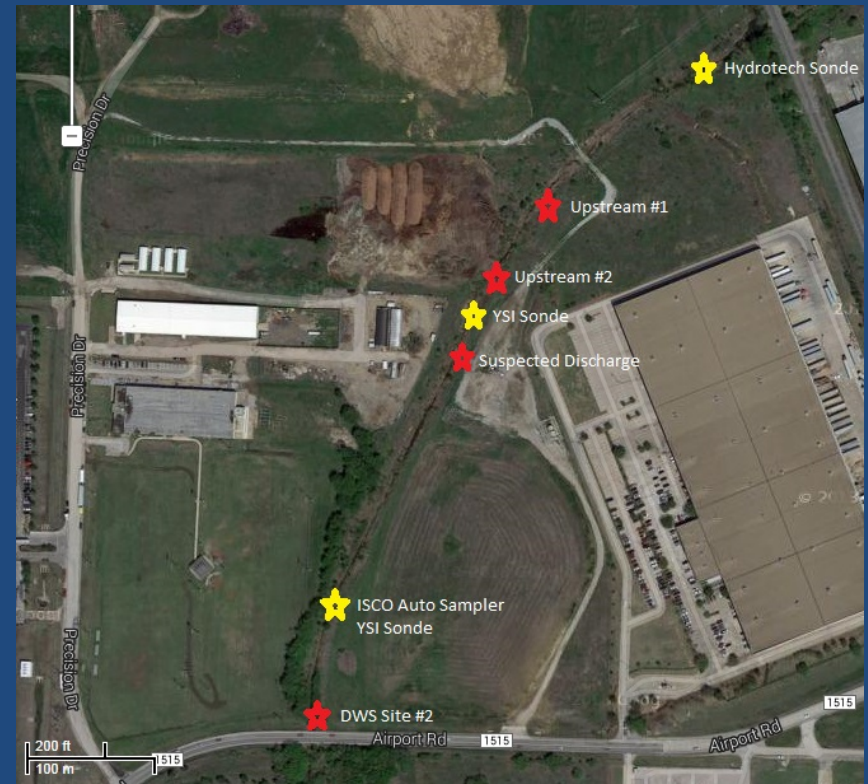
- Monitoring Information
  - ISCO auto sampler
    - Downstream of suspected discharge
  - Sonde Data (stars)
    - Upstream
    - Above Suspected Discharge
    - Pool Above Site 2 (ISCO)
- Grab Samples (stars)
