# Dry Weather Screening to IDDE : A Gas Well Incident - Case study

City of Denton

Watershed Protection

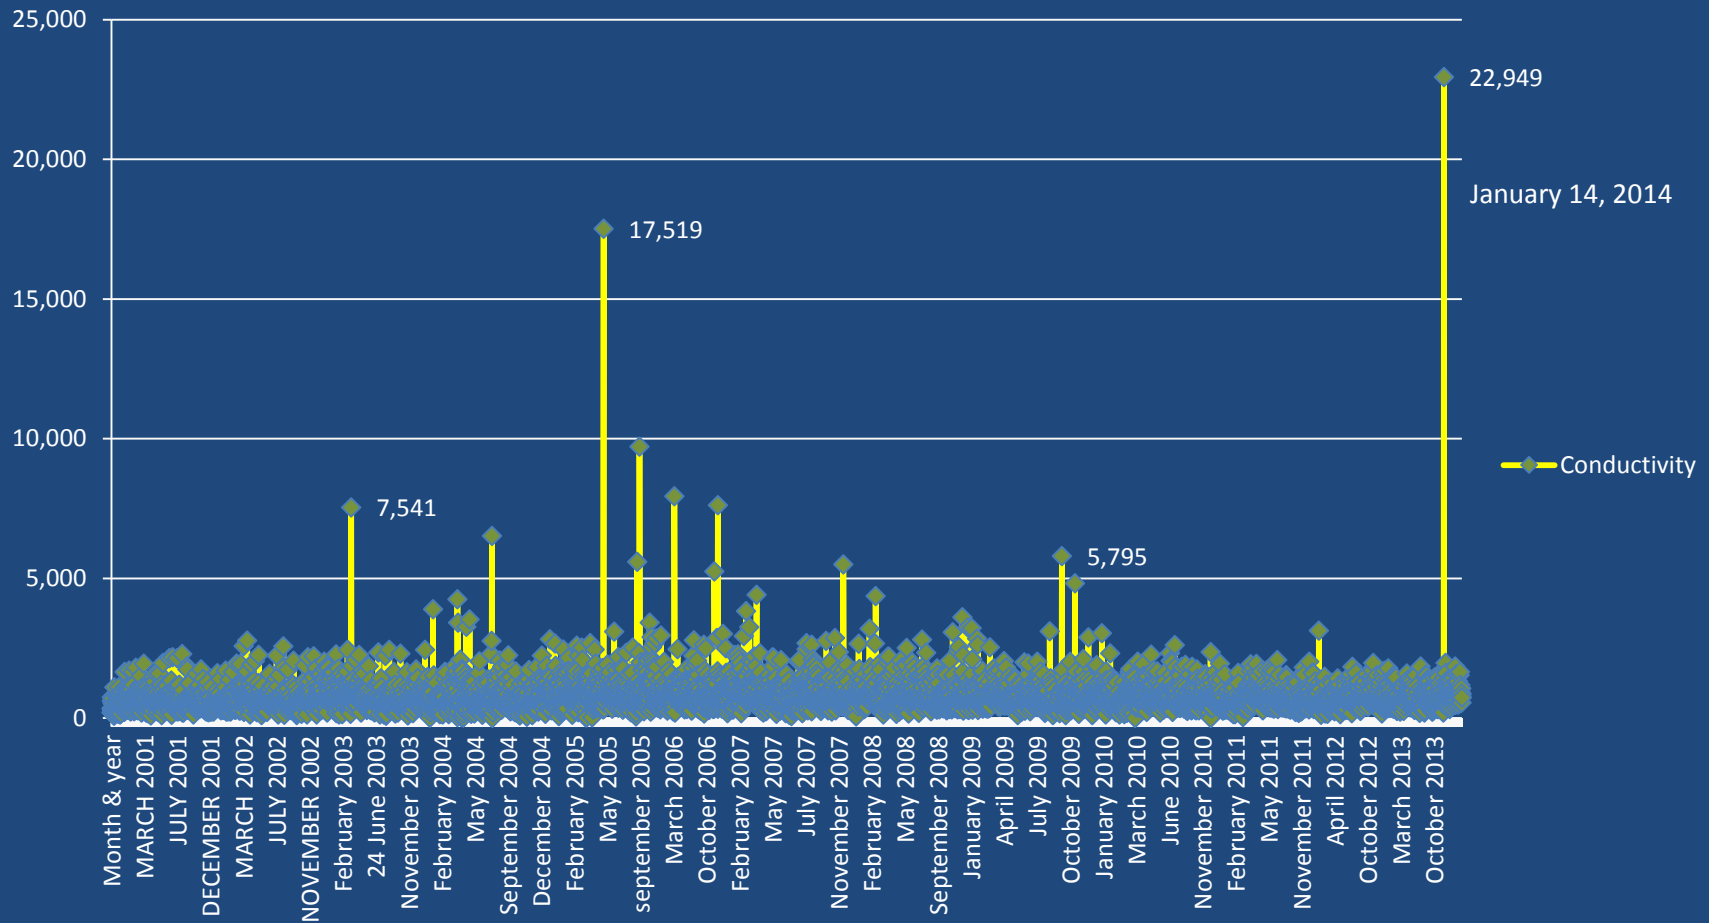
# Historic Conductivity in City of Denton

- Odd odor, reminiscent of hydrocarbons but not discernible (to me)
- Unusual sheen with black, fibrous splotches
- Conductivity reading of **26,000 us/cm**

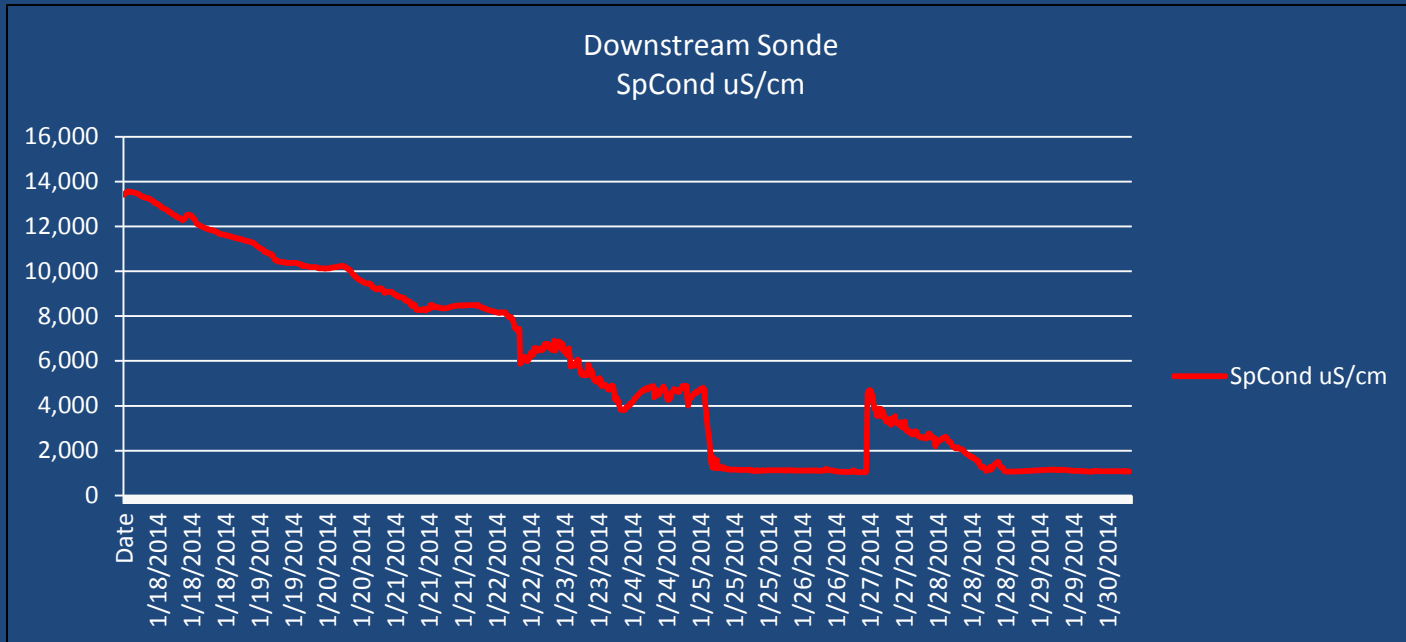
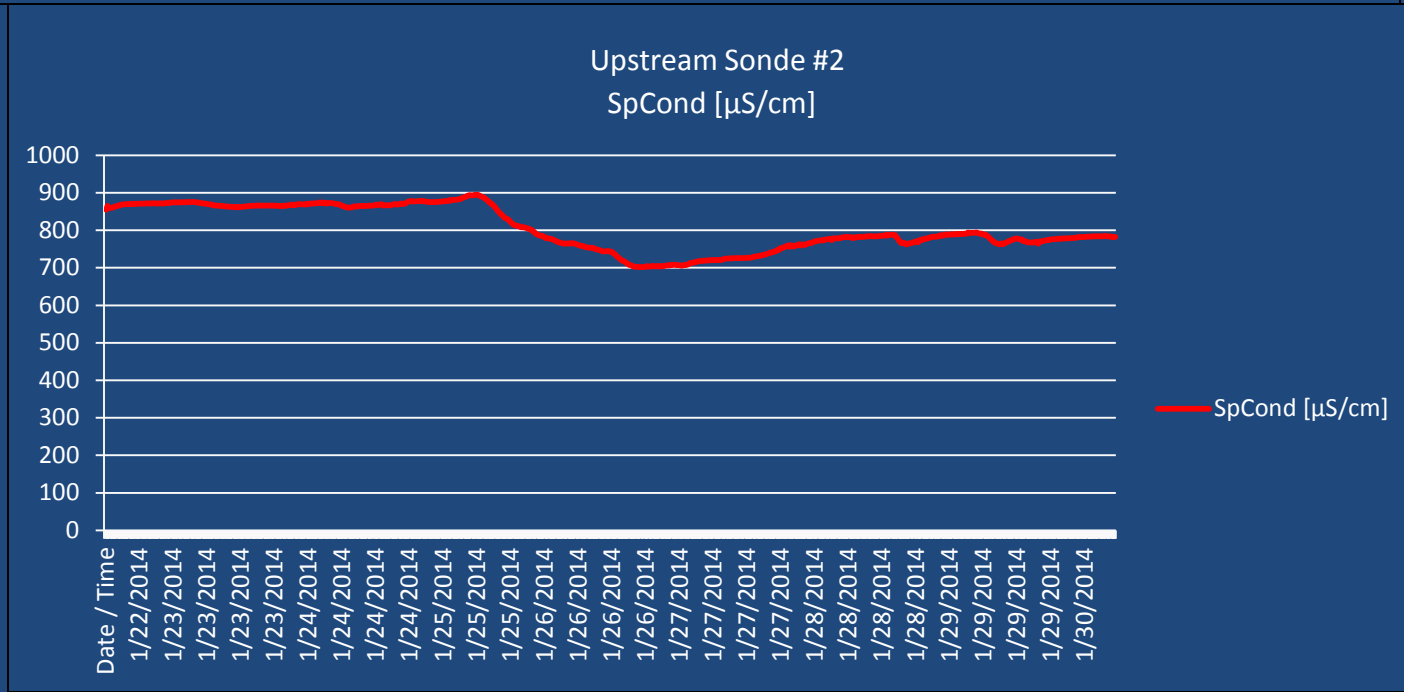
# Results

- Monitoring Information
  - ISCO auto sampler
    - Downstream of suspected discharge
  - Sonde Data (stars)
    - Upstream
    - Above Suspected Discharge
    - Pool Above Site 2 (ISCO)
- Grab Samples (stars)

- We determined something had occurred
  - Had data to back up this assertion
  - Gas Well Company Denied it to the end
  - Large degree of variability in results made our case difficult so legal did not pursue
- RRC confirmed there was something in the water that could have come from vicinity of storage tanks for proprietary drilling fluids

- (1) Immediately remove all free-standing produced fluids from the ground surface.*
- (2) Repair or replace all leaking equipment and BMPs.*
- (3) Conduct excavation operations to vertically and horizontally delineate all areas affected by produced fluids.*
- (4) Initiate and complete remedial clean-up operations for all areas affected by produced fluids to promote aeration and natural remediation.*
- (5) Provide the District Office with a remedial plan and documentation that all cleanup operations are complete.*
